Re: Visual Structural Review
123 Main St.
Overland Park, KS 12345

Daniel Schroeder, P.E.

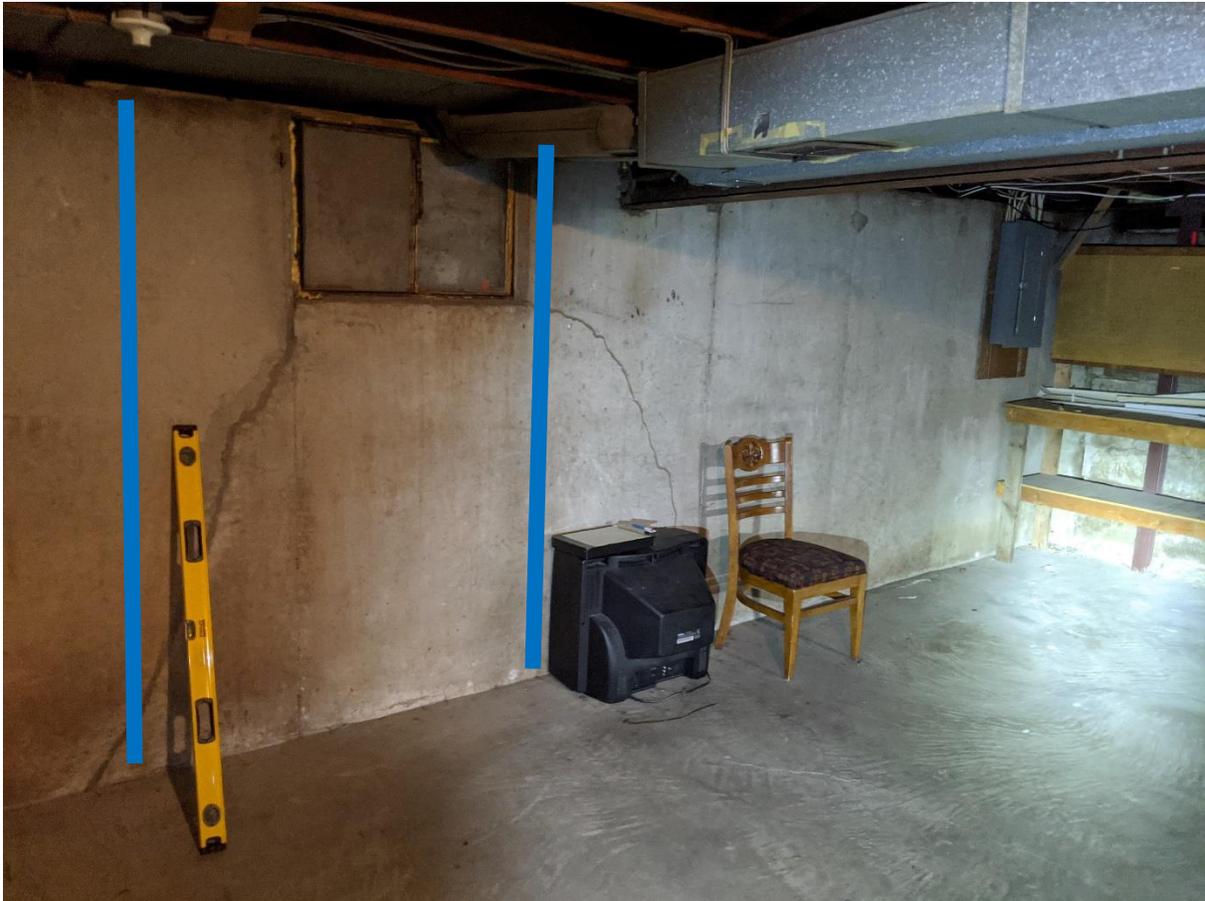
Excessive lateral movement was observed on the east end of the south wall; remediation is required. The wall has moved in approximately 2" as measured with a 4ft carpenter's level. 2 vertical I-beam braces should be installed, see Appendix B for location.

Approximate location of 2 braces

- Install 2 vertical I-beam braces on the east end of the south wall, spaced approximately 6ft on center (one on each side of the window, see Appendix B).
- Install mortar between the existing I-beam braces and the foundation walls, 2 on the west wall and 4 on the east wall.
